Austin Environmental Consultants, Inc.

January 23, 2019

Re: Harmony Site – Harmony, Osceola County, Florida
SFWMD Permit No. 49-01058-P
SFWMD Applic. No. 991227-13
Third Annual Mitigation Monitoring Report (Fall 2019)

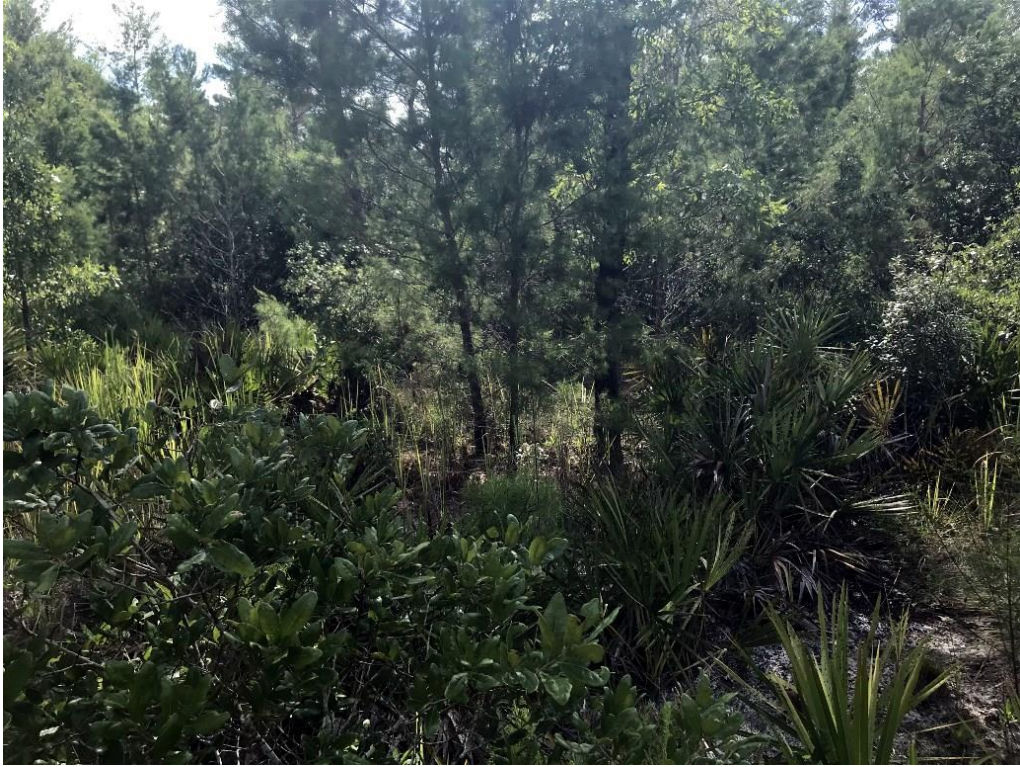
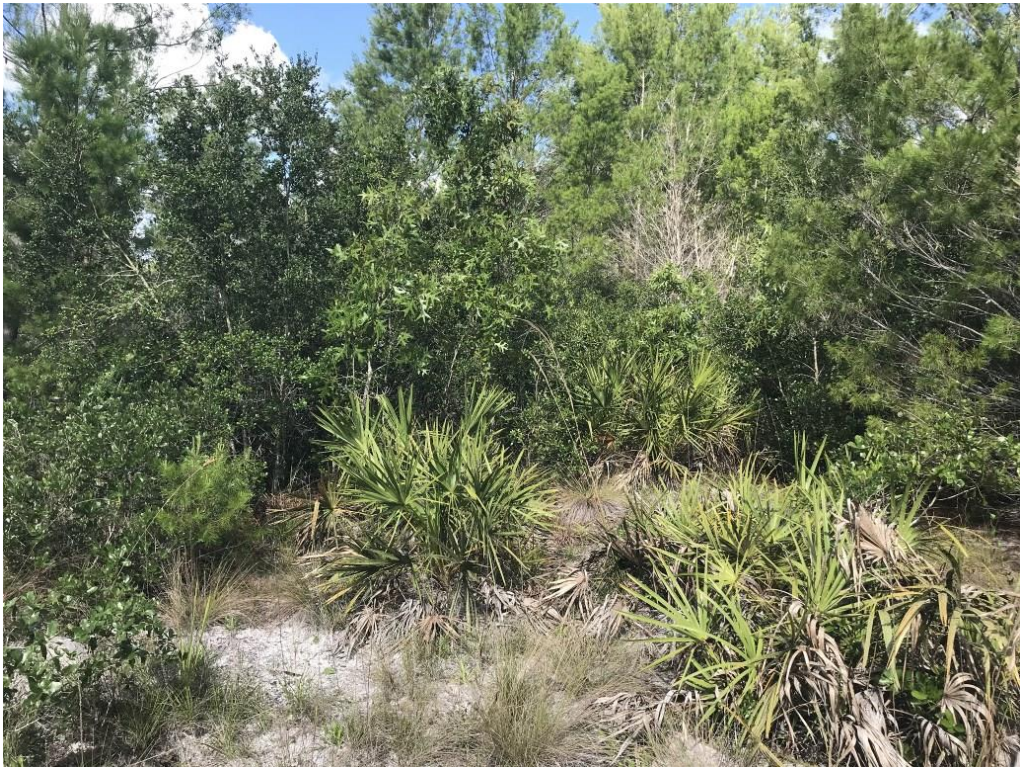
The xeric oak habitat along transect 1 is in excellent condition, with no observed exotic/nuisance plant species present. The plant community species composition is consistent with that described in the first annual monitoring report (see Appendix 2). Only a few scattered fallen sand pines (*Pinus clausa*) were observed, however, natural recruitment of desirable native species is evident.

UPLAND TRANSECT 1 AREA PHOTO (FACING EAST)

UPLAND TRANSECT 1 AREA PHOTO (FACING WEST)

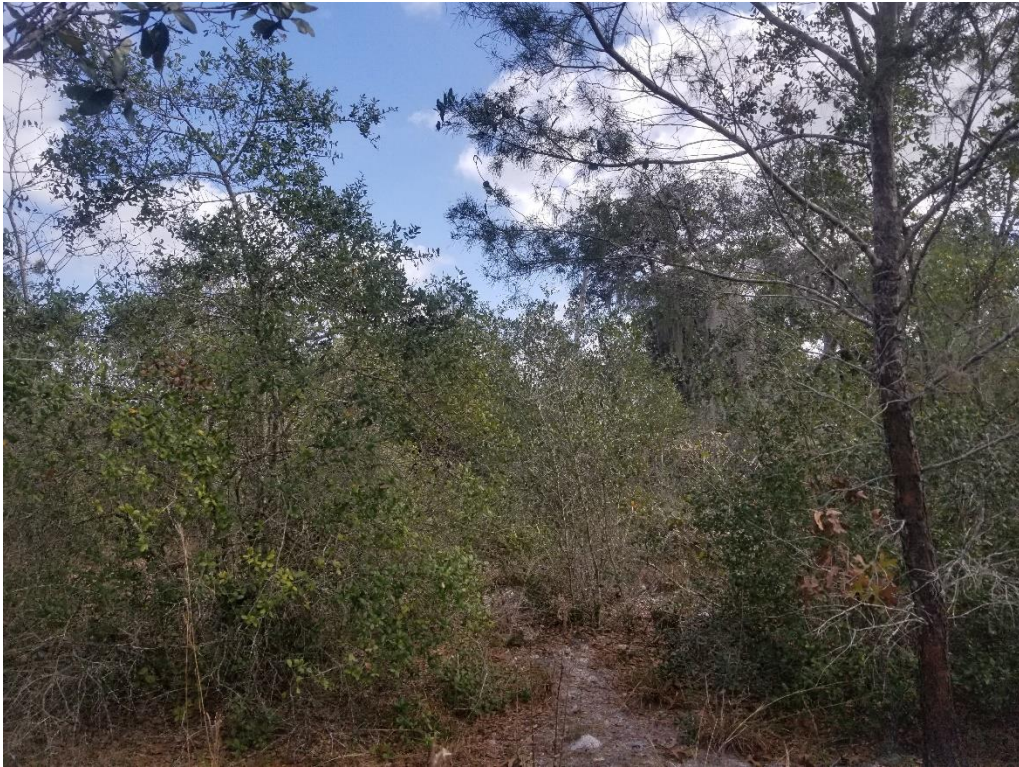
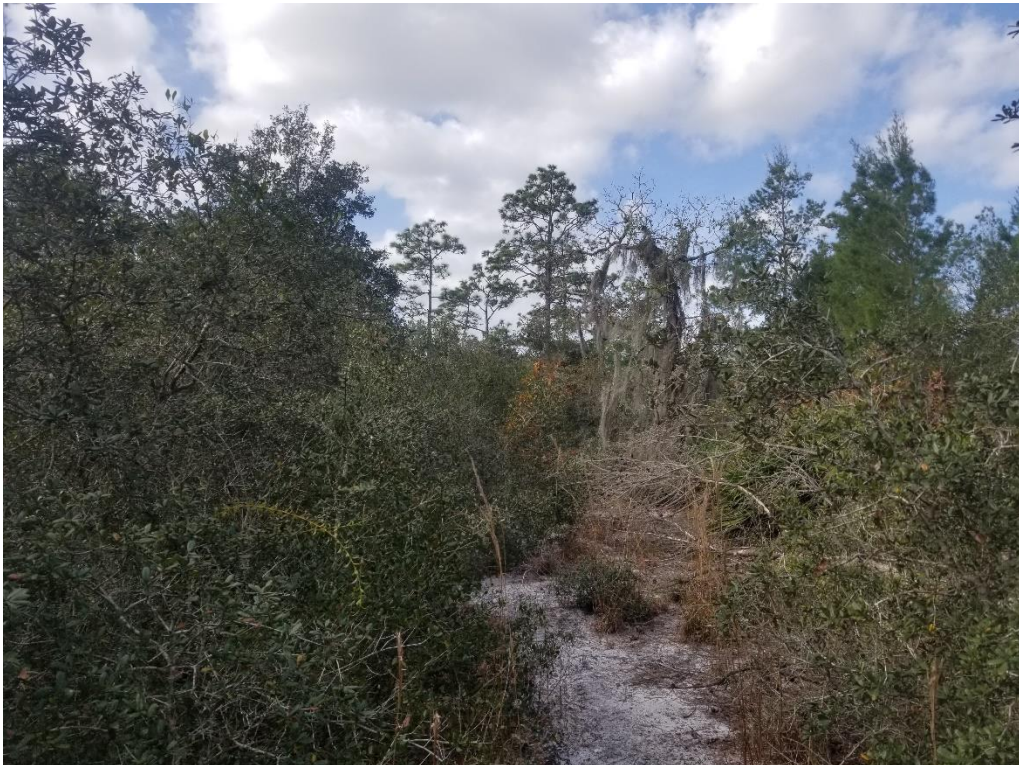
Exotic cogon grass (*Imperata cylindrica*) noted in the previous, Spring 2019 report, was not observed in the transect 2 area.

As with transect 1, which is located within the same area of xeric oak, the species present and percent coverage appeared consistent with that described in the first annual monitoring report.

UPLAND TRANSECT 2 AREA PHOTO (FACING EAST)

UPLAND TRANSECT 2 AREA PHOTO (FACING WEST)

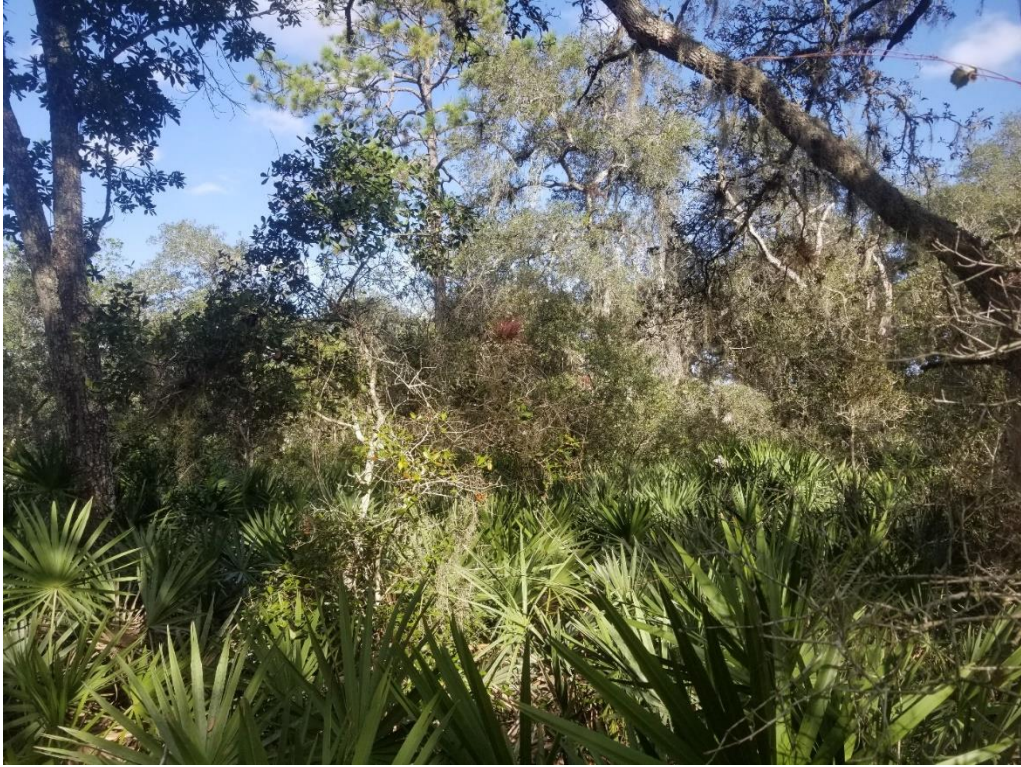
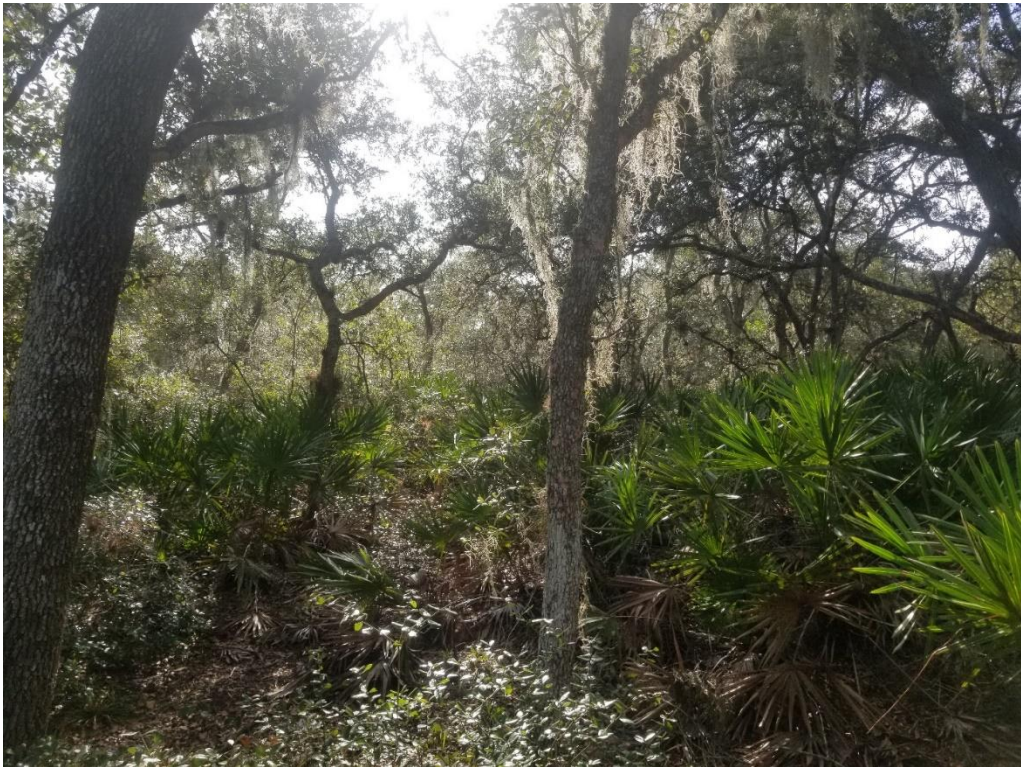
The xeric oak within transect 3 resembles a low oak hammock, with a very dense overstory and understory of sand live oak (*Quercus geminata*). Due to the long-term suppression of fire, the overstory has grown quite dense, and resulted in a thick layer of leaf litter, and sparse groundcover/shrub species. Species composition was consistent with the first monitoring report, and no exotic/nuisance plant species were observed.

UPLAND TRANSECT3 AREA PHOTO (FACING NORTH)

UPLAND TRANSECT3 AREA PHOTO (FACING SOUTH)

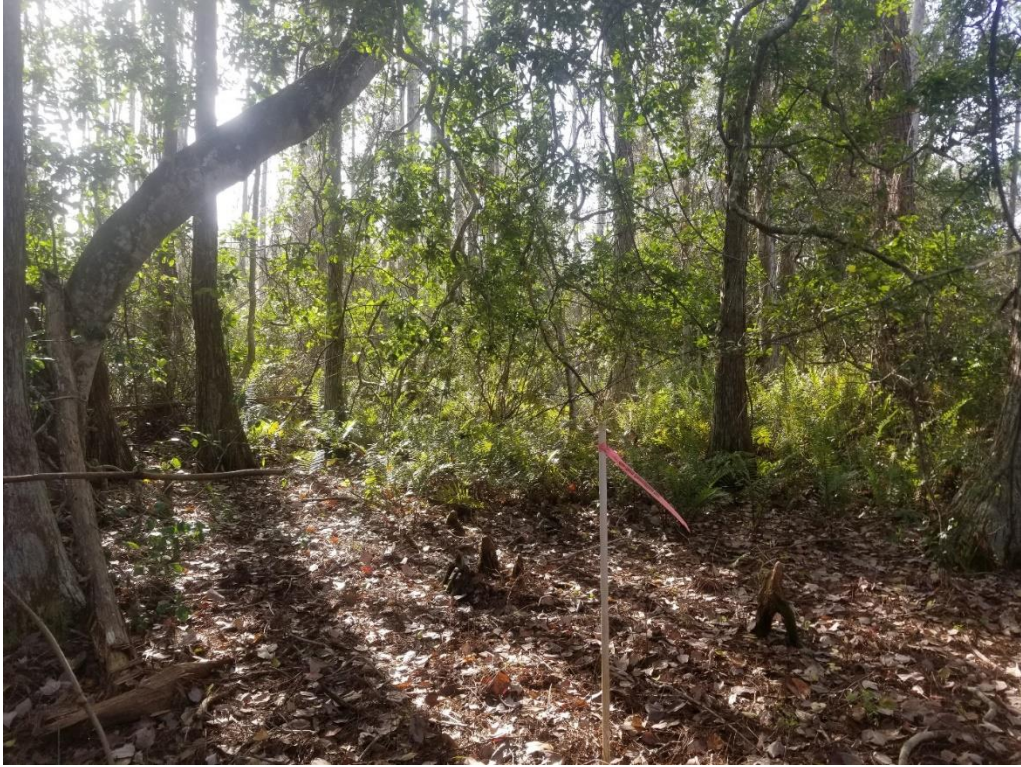
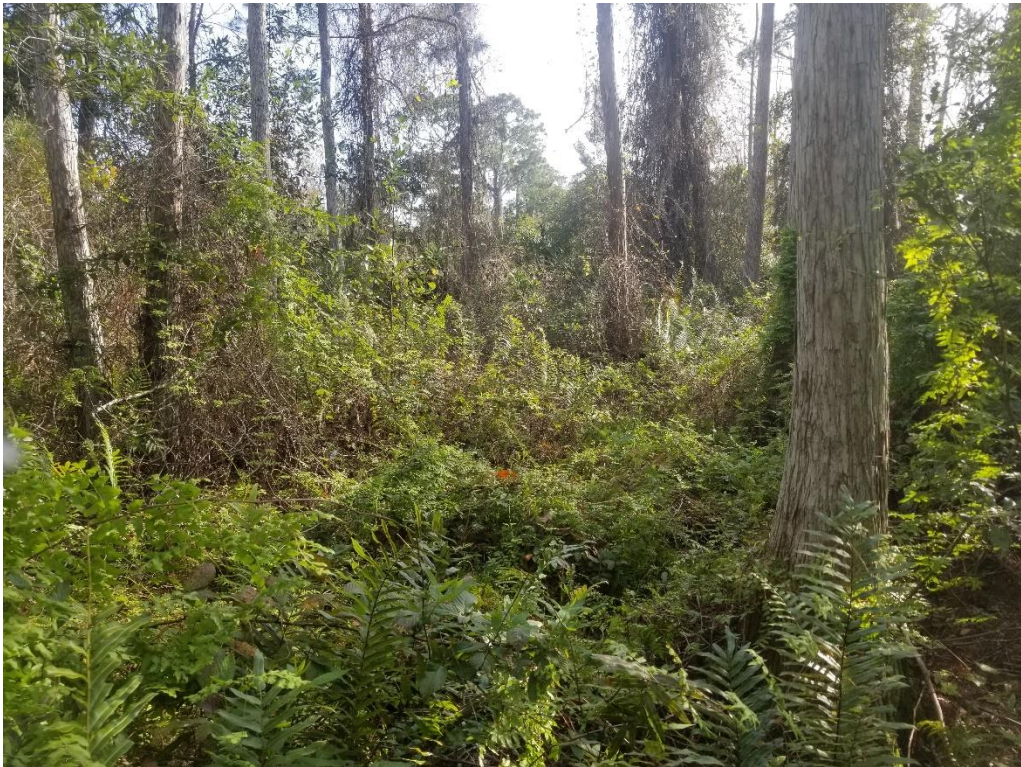
This portion of the wetland preservation area appears to be in good condition. Along the outer fringes in the upland portion of the wetland there was minor coverage of Caesar weed (*Urena lobata*).

Old world climbing fern (*Lygodium microphyllum*) recorded in the previous report was still prevalent during this monitoring event. This species represented a very minor component of the overall plant cover, however, due to its highly invasive nature, maintenance to prevent the spread of this species may be warranted. Management recommendations are outlined in a later section of this report.

WETLAND TRANESECT 1 AREA PHOTO (FACING SOUTH)

WETLAND TRANESECT 1 AREA PHOTO (FACING NORTHEAST)

Maintenance of Caesar weed and old world climbing fern is recommended, particularly along monitoring transect 4, and along the perimeter of the wetland in the vicinity of transects 1 and 2.

Maintenance of Caesar weed would consist of herbicide spot spraying. The eradication and maintenance of old world climbing fern is best accomplished through a combination of chopping and spot spraying. As this fern reproduces (potentially very long distances) by airborne spores, hand removal is not recommended. This activity results in the agitation of the spores and their release. Effective maintenance involves herbicide spot spraying of this vining fern where it occurs at the ground or in the shrub layer; and where it has encroached into the canopy, chopping the vine approximately 3 feet above the ground and spot spraying below.

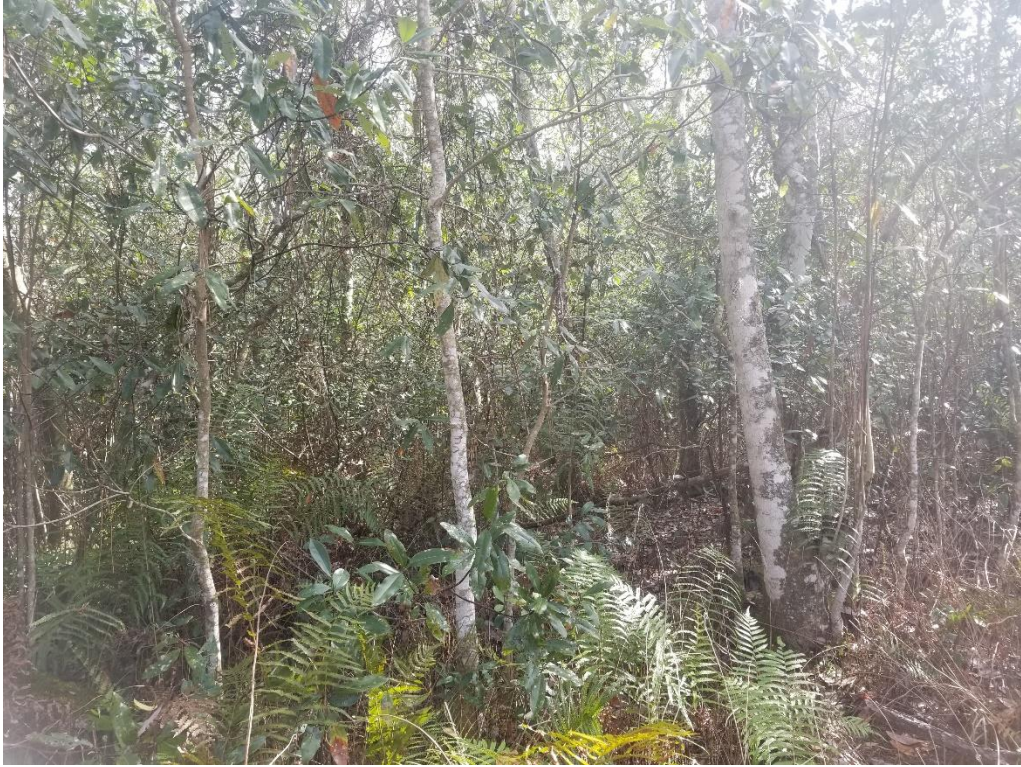
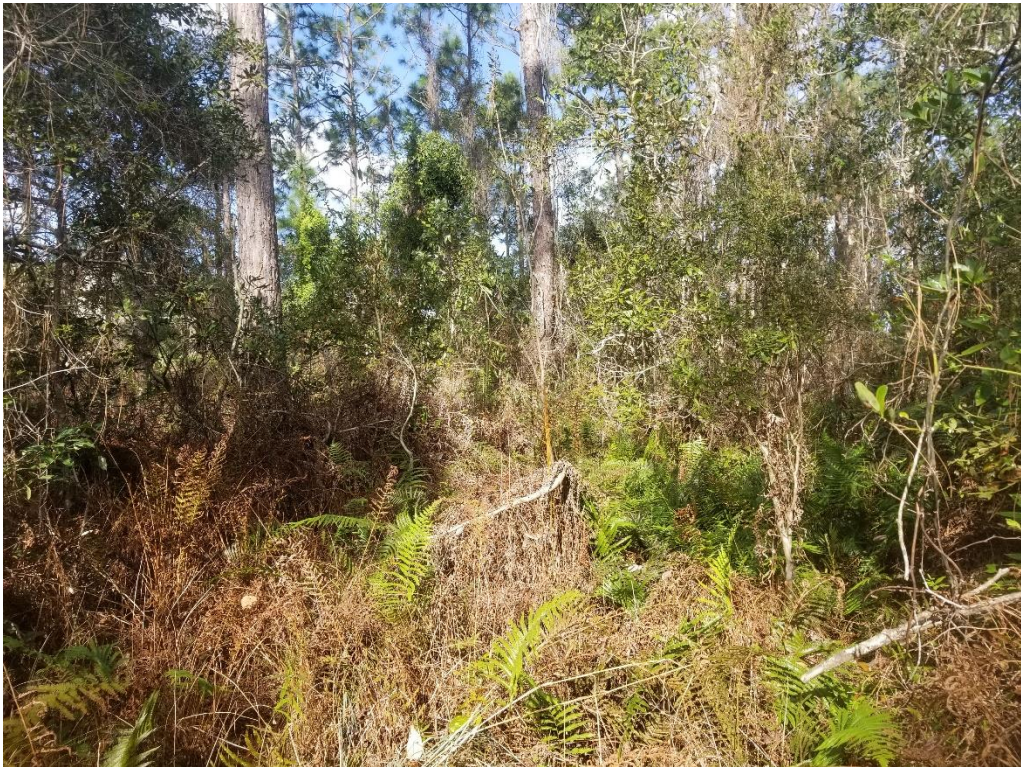
This portion of the wetland contains a mature canopy dominated largely by sweet bay (*Magnolia virginiana*) and pond cypress (*Taxodium ascendens*), with a very dense understory of immature sweet bay.

Observed vegetation in this transect area appeared consistent with those described in the first monitoring report. Old world climbing fern was not observed in this transect area and it may have been treated.

WETLAND TRANSECT 2 AREA PHOTO (FACING EAST)

WETLAND TRANSECT 2 AREA PHOTO (FACING WEST)

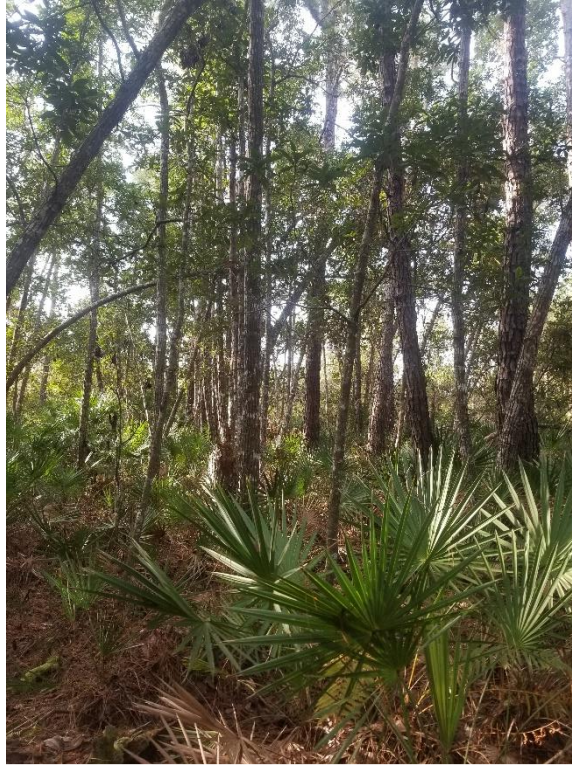
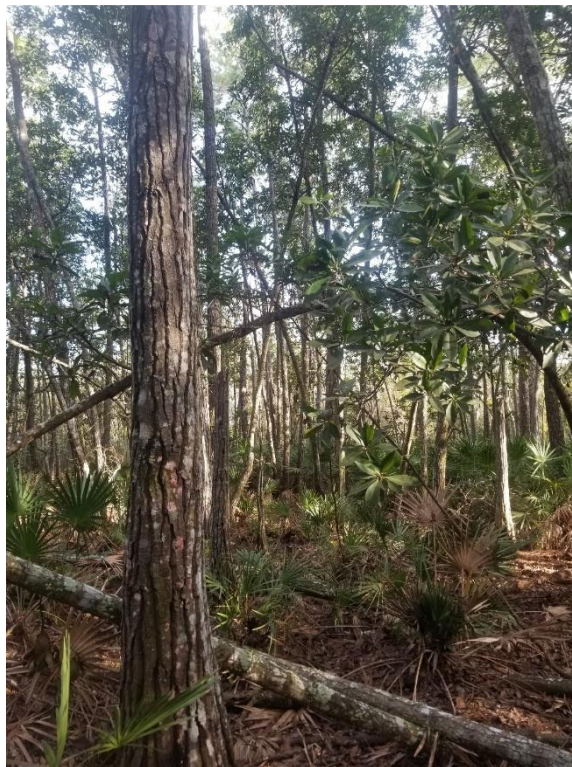
Transect 3 is located within a portion of the wetland that does not display signs of regular inundation. Vegetative composition within the canopy, subcanopy, and shrub/groundcover layers appears to be consistent with what was described in the first annual monitoring report. No exotic/nuisance species were encountered within this portion of the wetland.

WETLAND TRANSECT 3 AREA PHOTO (FACING EAST)

WETLAND TRANSECT 3 AREA PHOTO (FACING WEST)

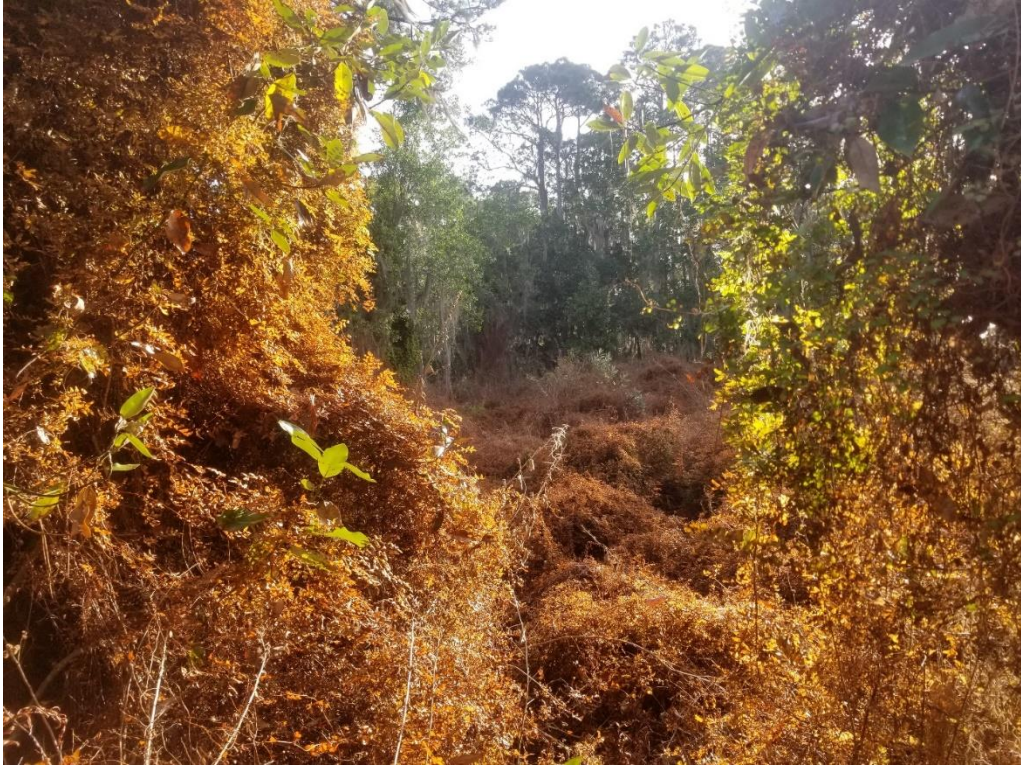
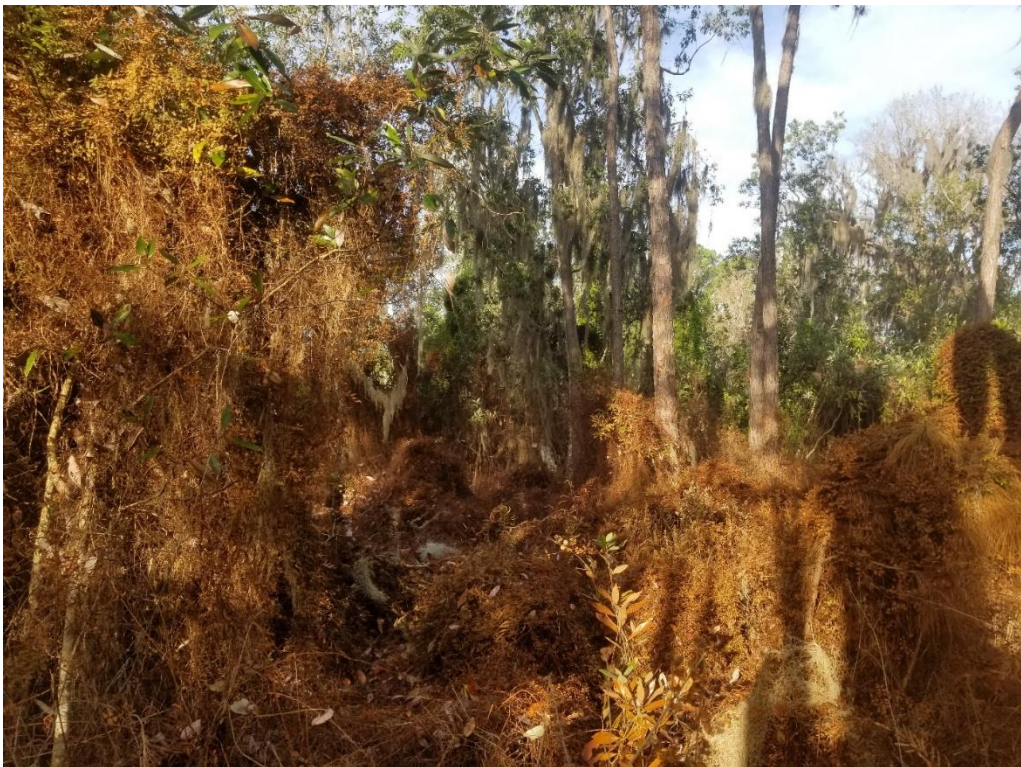
Species observed include loblolly bay (*Gordonia lasianthus*), slash pine (*Pinus elliottii*), and sweet bay (*Magnolia virginiana*) which is consistent with the prior monitoring report. The old world climbing fern mentioned in the previous report has been treated as the ground cover was dominated by treated/dead old world climbing fern.

WETLAND TRANSECT 4 AREA PHOTO (FACING EAST)

WETLAND TRANSECT 4 AREA PHOTO (FACING WEST)

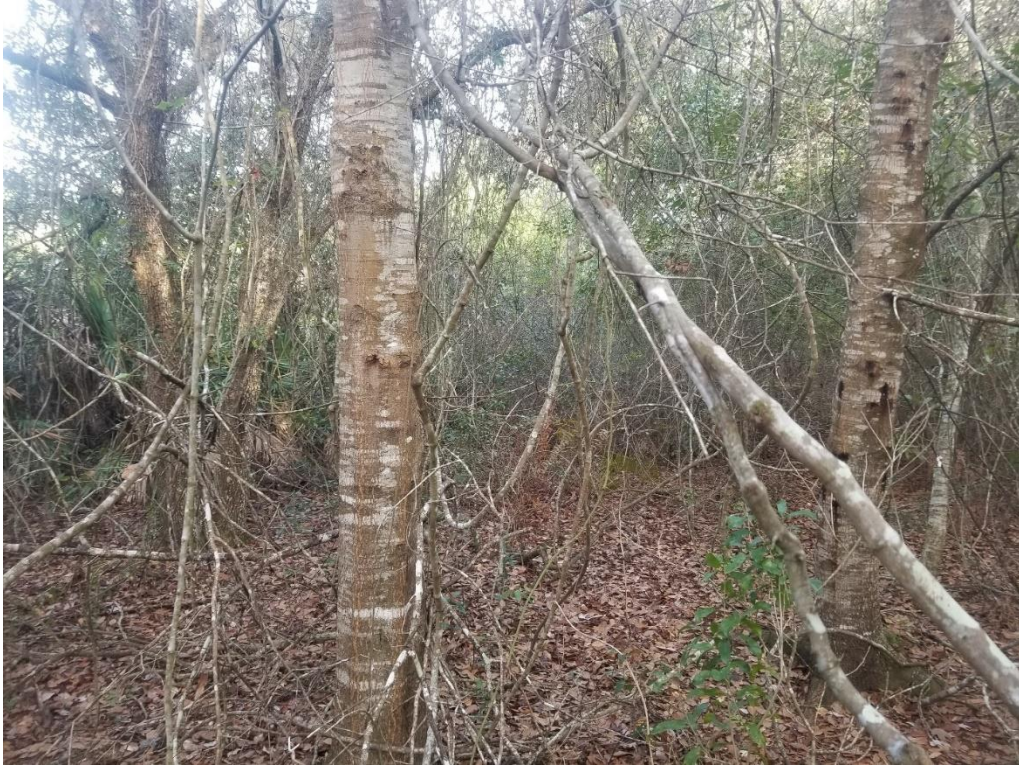
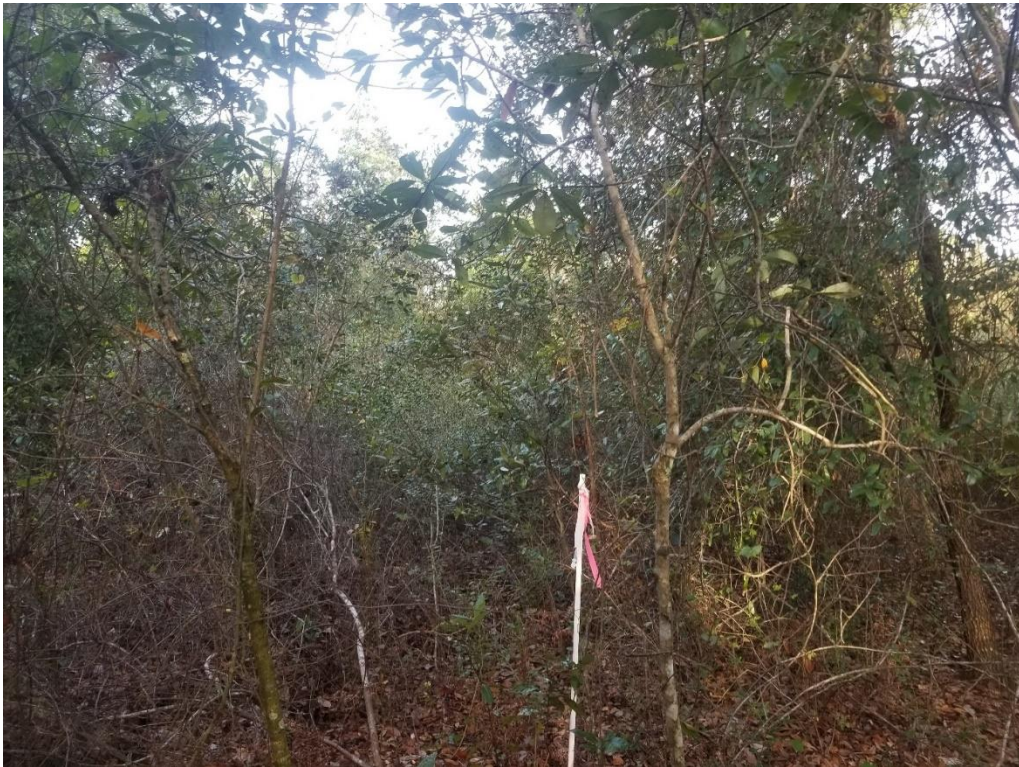
Transect 5 also occurs within a drier portion of the preserved wetlands. Although the observed tree and understory species appeared consistent with the first annual monitoring report, the fox grape (*Vitis rotundifolia*) and greenbriar (*Smilax spp.*) mentioned in the second report appeared to have died back and are not as prevalent as stated previously.

WETLAND TRANSECT 5 AREA PHOTO (FACING EAST)

WETLAND TRANSECT 5 AREA PHOTO (FACING WEST)

Maintenance of grape vines that remain along Transect 5 is also recommended to reduce this nuisance species and allow for other native species to proliferate.
